**Alabama State Port Authority**  
**Addendum to R&P or Specification Booklet**

**Project Name** ASPA Logistics Park Civil Infrastructure Improvements

**Project No.** 11271 **Task No.** 01 **Addendum No.** 1

RE: Condition Inspection of Seven 60 inch HDPE Temporary Drainage Pipes  
ICTF Garrows Bend

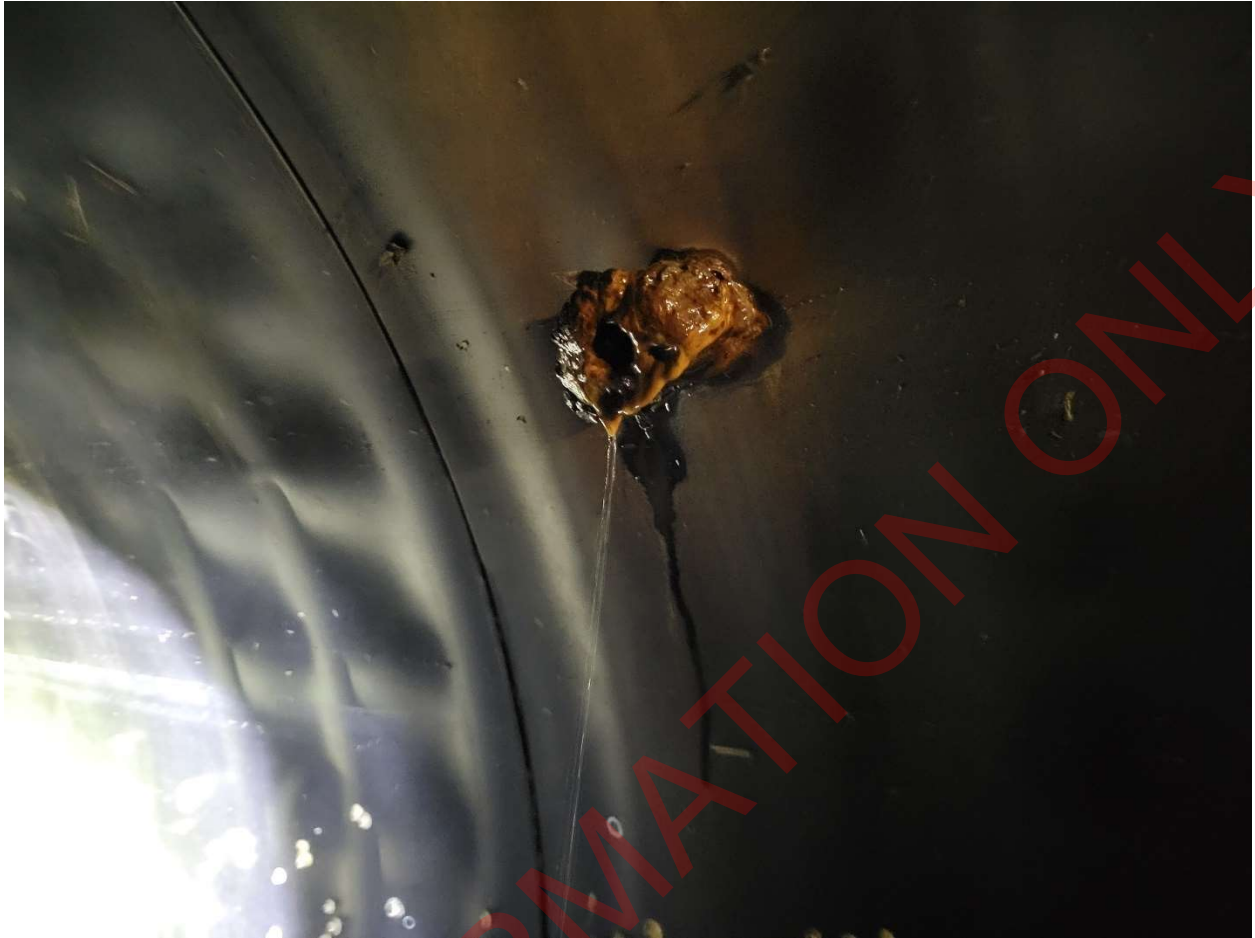
**Repair in Pipe No. 7 Remains in Good Condition**

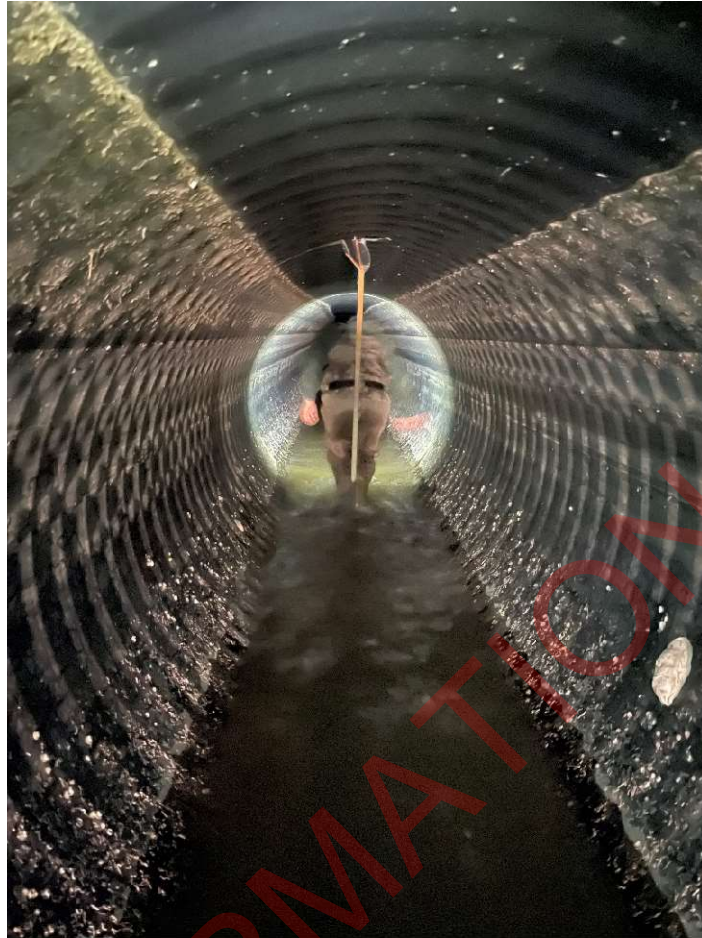
There was no notable differential settlement that could be visually observed in the pipes. The pipes all appeared to be straight and flat on grade. The vertical height inside the pipes was measured at regular intervals and found to be 57.48 to 60.48 inches. Measurements can be found in the table included at the end of this report. All joints looked good except for at the elbow fitting; the joints at the elbow fitting are leaking water and have efflorescence. As well, there is some slight joint misalignment at the elbow fittings. Sedimentation buildup was present in all pipes and consisted of sand and muck up to 12 inches deep in pipes 5 through 7, and sand and muck up to 6 inches deep in pipes 1 through 4. Debris consisting of small quantities of rip rap, trash, and pieces of driftwood were encountered during inspection. Marine growth consisting of oysters, mussels, and barnacles is present in all pipes and is greatest towards the outlet ends. The previously repaired damage in Pipe No. 7 remains in good condition. Several small hairline cracks were observed in the inner lining of the pipes. These cracks have some leakage, likely resulting from the annular space between the inner and outer linings of the pipe where water may become entrapped during high tides. These minor cracks do not appear to extend through the outer lining of the pipes. An electrical ground rod that was driven through the top of Pipe No. 2 is located approximately 110 ft from the inlet end. The HDPE of the outer shell is sealed tightly around the rod and is not leaking. A piece of the inner liner, measuring approximately 4 inches in diameter, is broken out at the top of the pipe at the location of the ground rod. If the ground rod is removed, the pipe will need to be repaired in this location. The ground rod has the potential to catch debris. Overall, the pipes are in good condition.

**Electrical ground rod in Pipe No. 2**

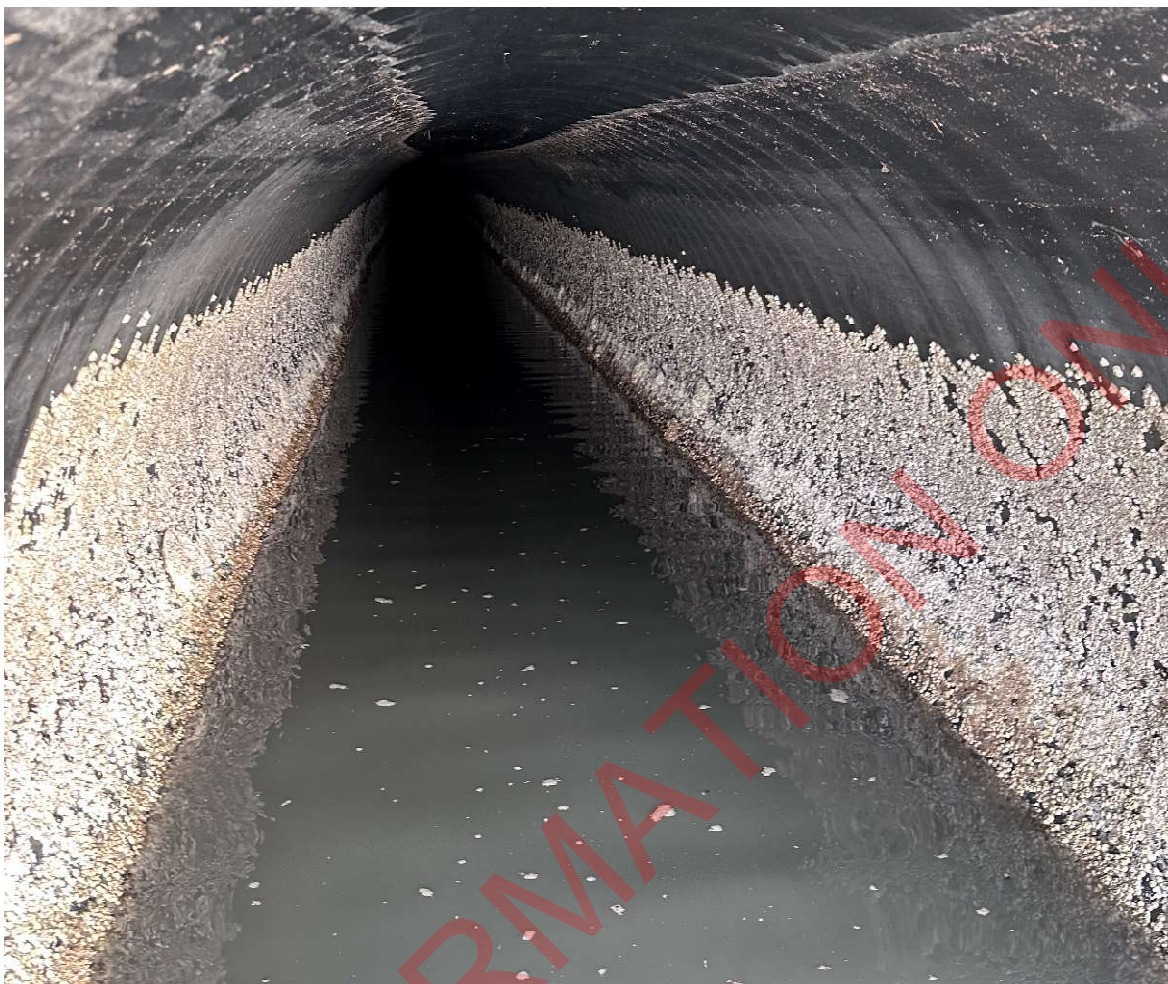
**Typical condition of pipes near outlet**

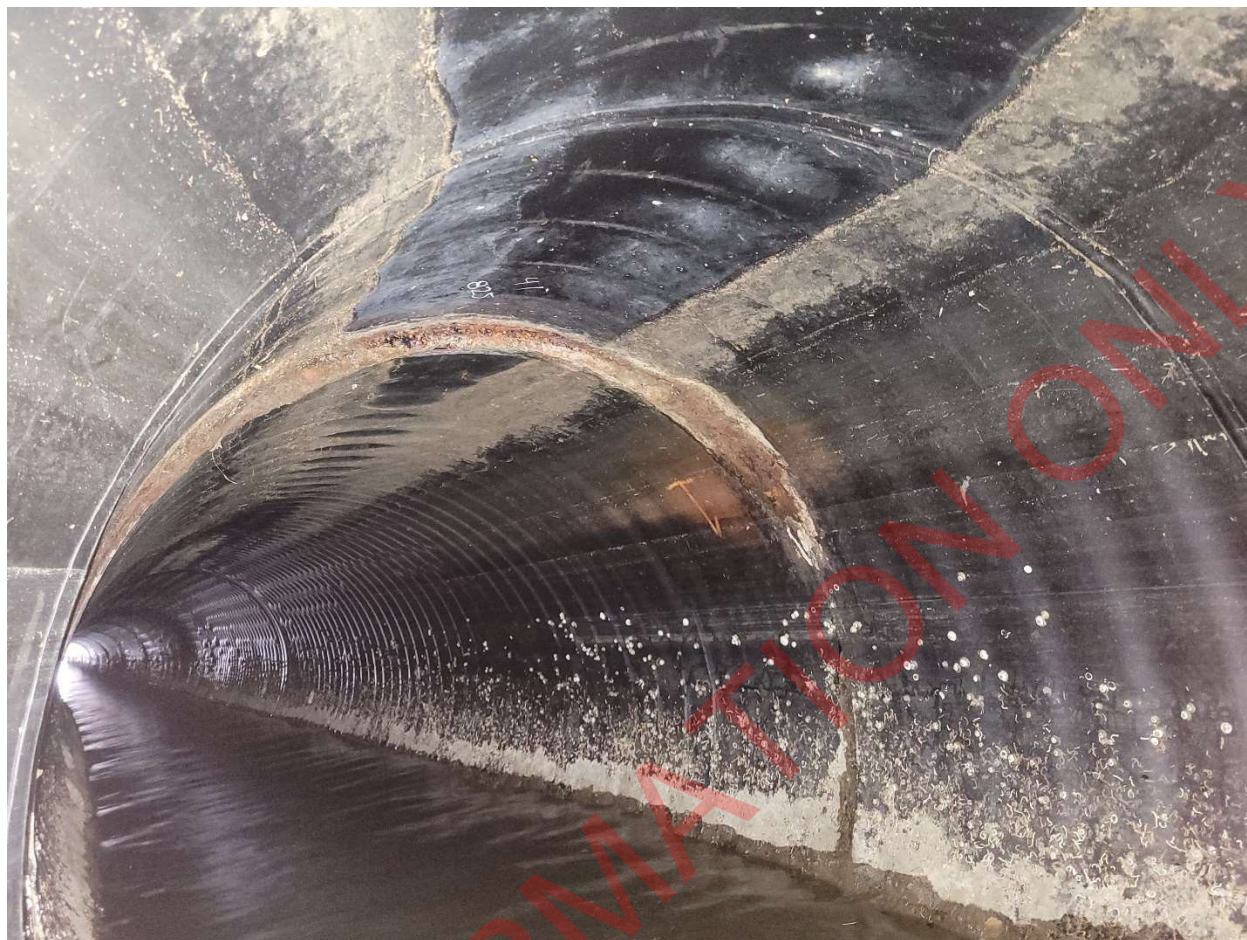
**Typical Efflorescence at Elbow Joint & Typical Marine Growth**

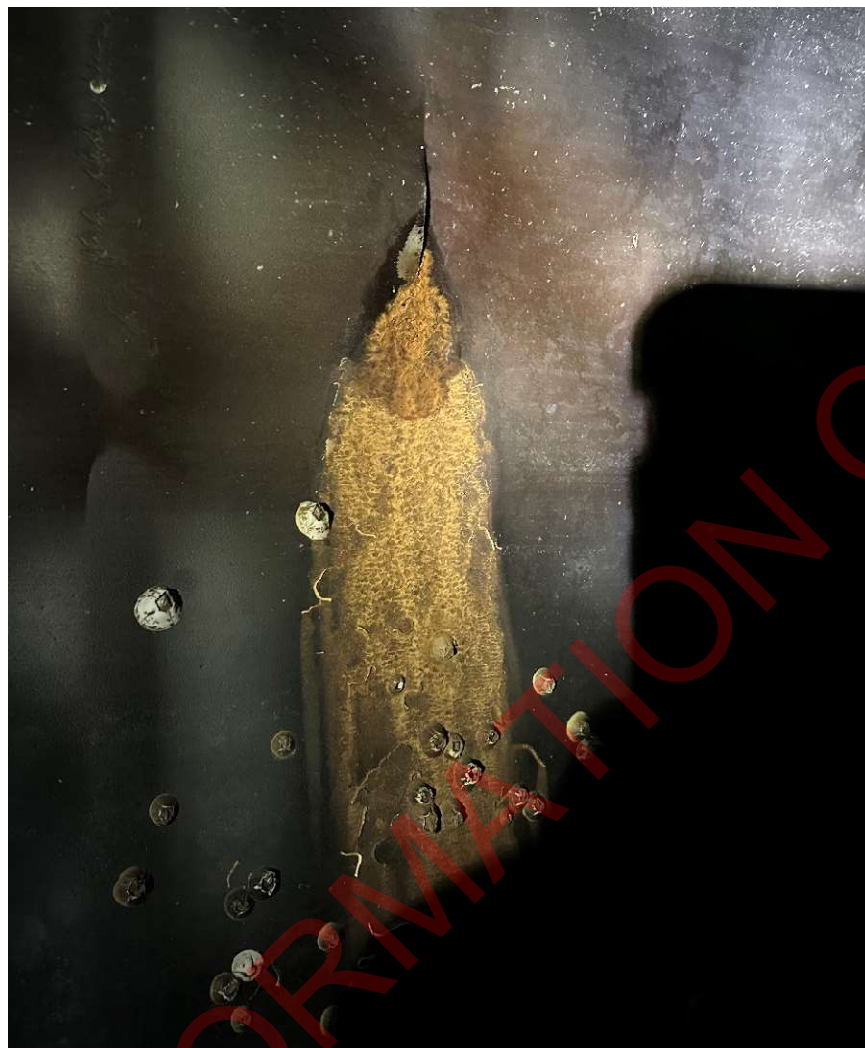
**Typical Minor Hairline Crack in Inner Lining of Pipe**
